INSPECTION REPORT

SAMPLE REPORT

Inspection Date: Tuesday, December 21, 2021 Prepared by: Travis Halldorson

Wizard Home Inspections 9711 Cedar Pl Summerland, BC V0H1Z2 250-274-2047

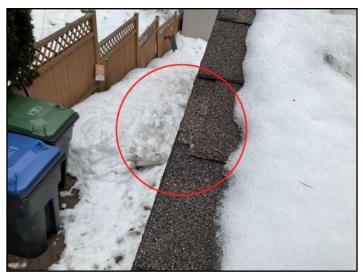
4. Condition: • Damage

Small damaged corner observed. Inspect roof for other similar damaged areas when roof is clear from snow. **Implication(s)**: Chance of water damage to structure, finishes and contents **Location**: Roof

5. Damage

Task: Further evaluation

Time: After snow melt

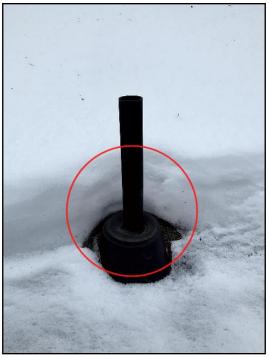
5. Condition: • Damage

Implication(s): Chance of water damage to structure, finishes and contents

6. Collapsed boot

Task: Replace

Time: Before next winter season

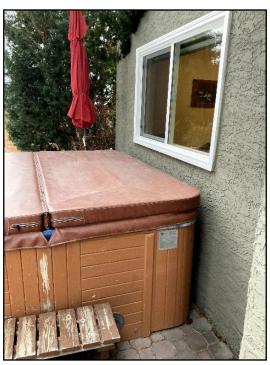
6. Condition: • Hot tub is too close to house.

Implication(s): Water leaks may damage contents, materials and structure and create mold.

11. Too close to siding

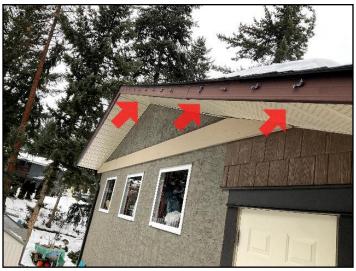
9. Condition: • <u>Damage</u>
Fascia has unsealed nail penetrations from Christmas light anchors.
Implication(s): Chance of water damage to structure, finishes and contents
Location: Left Side Exterior

17. Damage

Task: Seal holes - Repair or replace fascia

Time: Prior to next winter season

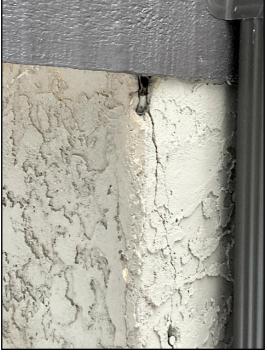
10. Condition: • Cracks & Damage

Stucco is damaged in various locations and should be repaired to prevent water infiltration.

Implication(s): Chance of water damage to structure, finishes and contents I Material deterioration I Possible hidden damage

18. Cracked

Task: Repair/Seal all openings and cracks

Time: Upon possession

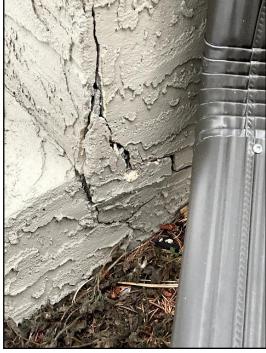
19. Cracked

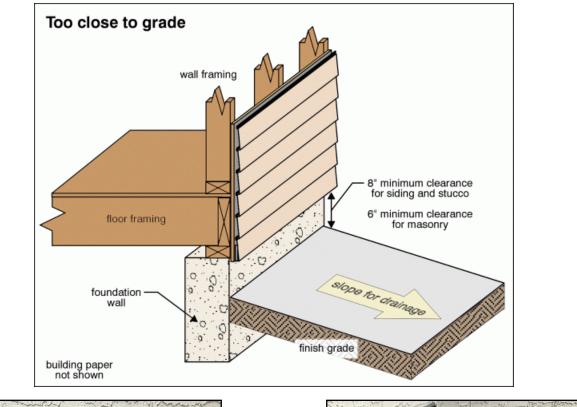
11. Condition: • Too close to grade

Implication(s): Chance of water damage to structure, finishes and contents | Material deterioration | Potential hidden damage

22. Too close to grade

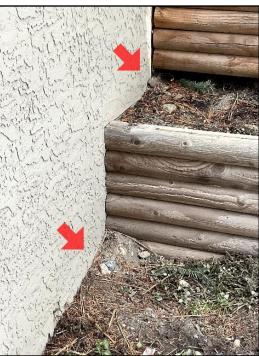
24. Too close to grade

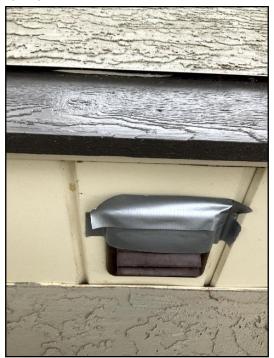
13. Condition: • Cover damaged

Dryer vent and basement bathroom exhaust vent are damaged and need repair.

29. Cover damaged

Task: Repair

Time: Upon possession

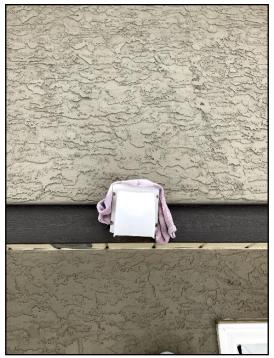
30. Cover damaged

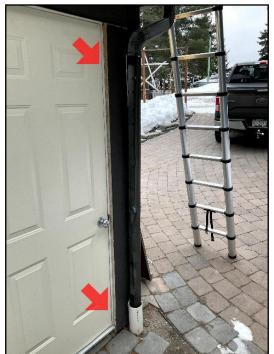
16. Condition: • Paint or stain needed

Implication(s): Chance of water damage to structure, finishes and contents | Material deterioration

35. Paint or stain needed

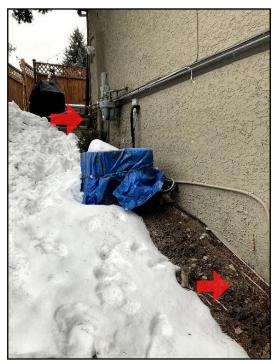
19. Condition: • Improper slope or drainage

40. Improper slope or drainage

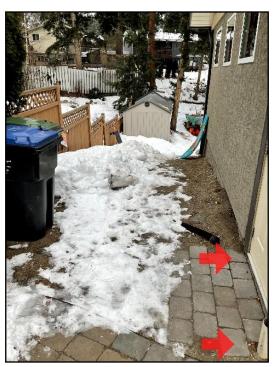
41. Improper slope or drainage

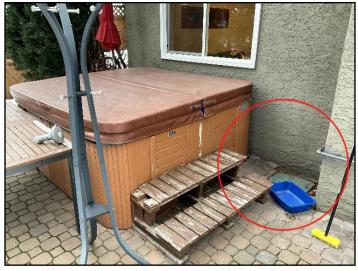
42. Improper slope or drainage

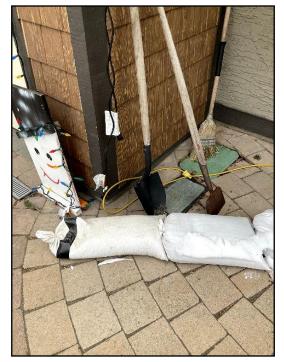
21. Condition: • Poor service location for irrigation system. They are both situated near foundation wall at a low spots and if a leak were to ever occur a water could find its way into the home.

Implication(s): Water leaks may damage contents, materials and structure and create mould.

44. Irrigation

Task: Water leak alarm is suggested to prevent serious water damage

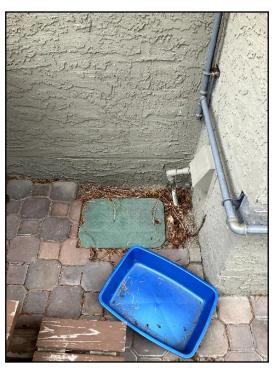
45. Irrigation

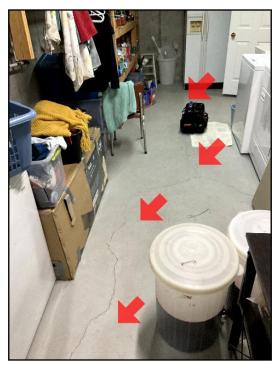
22. Condition: • Settled

Evidence that the house has settled. Ask seller settlement history and if this is new or old. Ask seller if this issue has been investigated by professional to determine cause and request report. If cracks and settlement are new or no investigation has been conducted, have area further evaluated by engineer to determine cause and provide a recommendation. The slab sounds hollow in areas which indicates possible water undermining. Implication(s): Chance of further structural movement Location: Basement utility area Task: Further evaluation / Request disclosure Time: Before subject removal

46. Settled

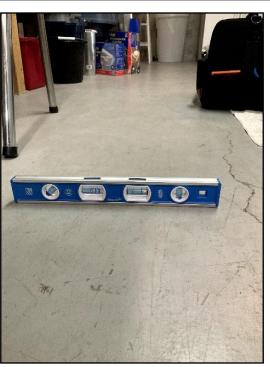
47. Settled

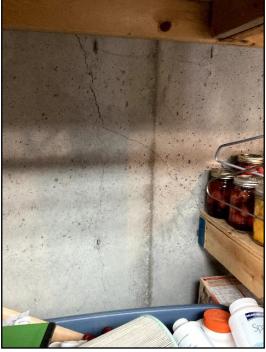
23. Condition: • Cracked horizontally

Horizontal cracks larger that 1/8th of an inch found in foundation wall. These cracks should be sealed by processional. Further investigation by foundation specialist is recommended to assure future structural movement is not an issue.

50. Cracked horizontally

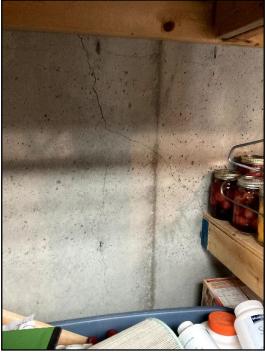
51. Cracked horizontally

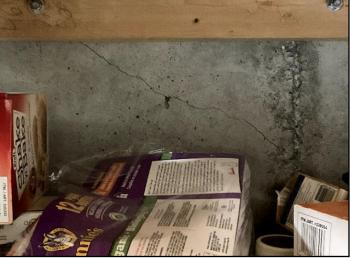
52. Cracked horizontally

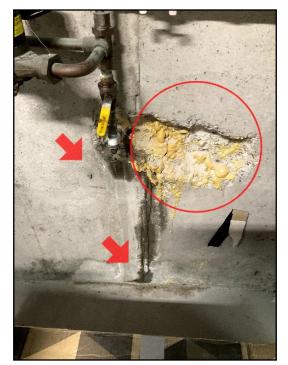
24. Condition: • Mechanical damage

Concrete around water main has been damaged. This area has an active water leak and requires repair. Implication(s): Chance of water entering building I Weakened structure I Chance of structural movement Location: Basement Utility Room

53. Mechanical damage

Task: Repair & Further evaluation

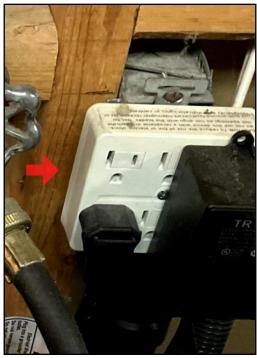
28. Condition: • GFCI Recommended
It is recommended that outlets near all sinks or water sources be GFCI protected.
Implication(s): Electric shock
Location: Laundry Area
Task: Install GFCI's
Time: Upon possession

59. GFCI Recommended

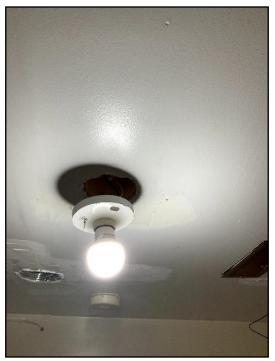
31. Condition: • Loose
Implication(s): Electric shock | Fire hazard
Location: Basement
Task: Repair
Time: Upon possession

63. Loose

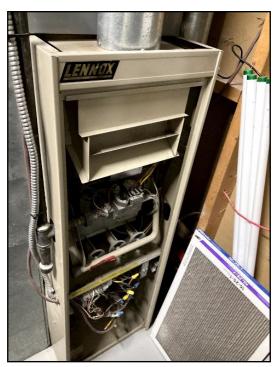
64. Furnace

33. Condition: • Past life expectancy

Old furnace, have heating specialist estimate remaining life and replacement costs, anticipate replacement. 35 year-old furnace, typically these furnaces last 18 to 25 years. If furnace fails, there will be no heat. Potential health issue if furnace not serviced.

Implication(s): Equipment failure I No heat for building I Possible hazardous combustion products entering home **Location**: Basement Furnace Room

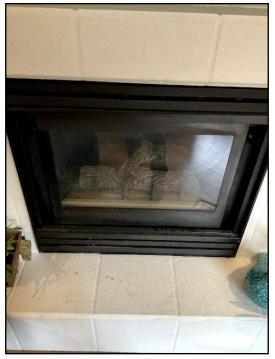
34. Condition: • Gas Service

72. Gas Service

Task: Have serviced by professional

Time: Prior to use and as regular maintenance

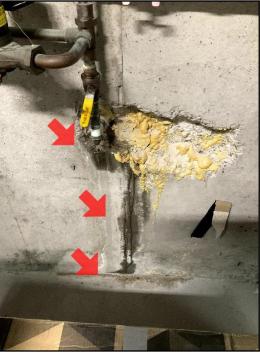
36. Condition: • Leak

81. Leak

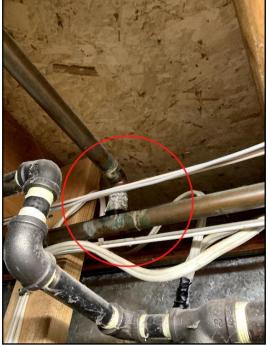
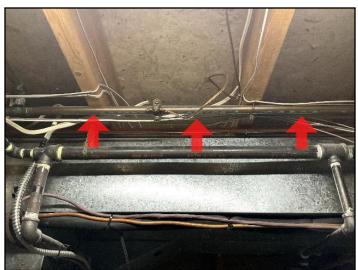
37. Condition: • Corroded copper pipe
Implication(s): Chance of water damage to structure, finishes and contents
Location: Basement Utility Room
Task: Review and repair by Plumber
Time: Upon possession

83. Corroded copper pipe

82. Corroded copper pipe

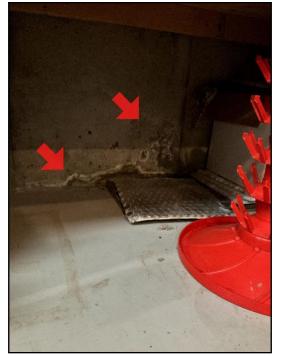
BASEMENT \ Wet basement - evidence 46. Condition: • Efflorescence

111. Efflorescence

Task: Further evaluation

Time: Upon possession

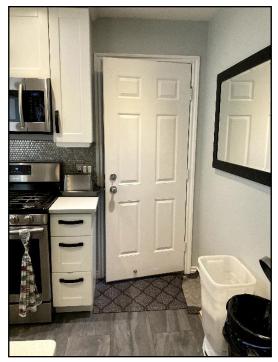
Condition: • <u>No self closer</u> Garage doors should always have self closing hinges. Implication(s): Hazardous combustion products entering home Location: Garage Task: Improve Time: Upon possession or before parking vehicle inside.

113. No self closer
