INSPECTION REPORT

SAMPLE REPORT

Inspection Date: Tuesday, December 21, 2021 Prepared by: Travis Halldorson

Wizard Home Inspections 9711 Cedar Pl Summerland, BC V0H1Z2 250-274-2047

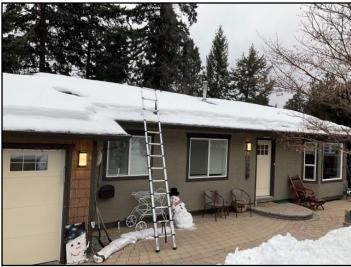
2. Snow/ice/frost

Roof was covered by snow during inspection. Ask seller details on approximate age of roof and its history. There was no evidence inside attic or house of any leak history.

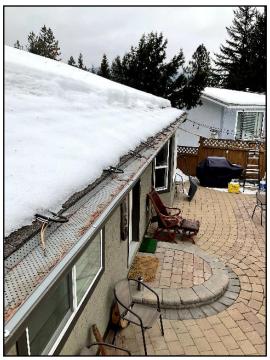
4. Gutter guards

3. Condition: • Gutter guards are installed on gutters. These help keep debris from getting into gutters. An annual cleaning and gutter check is still advised.

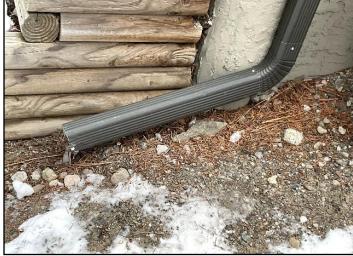
15. Should discharge 6 feet from building

8. Condition: • Should discharge 6 feet from building

Make sure all downspouts discharge water 6 feet away from building and lot grade slopes away from house. Implication(s): Chance of water damage to structure, finishes and contents | Water can undermine the foundation causing settlement

Task: Recommend installation of extension to ensure proper drainage away from foundation

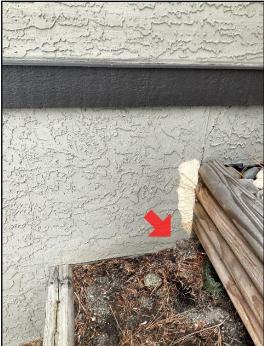
22. Too close to grade

11. Condition: • Too close to grade

Implication(s): Chance of water damage to structure, finishes and contents | Material deterioration | Potential hidden damage

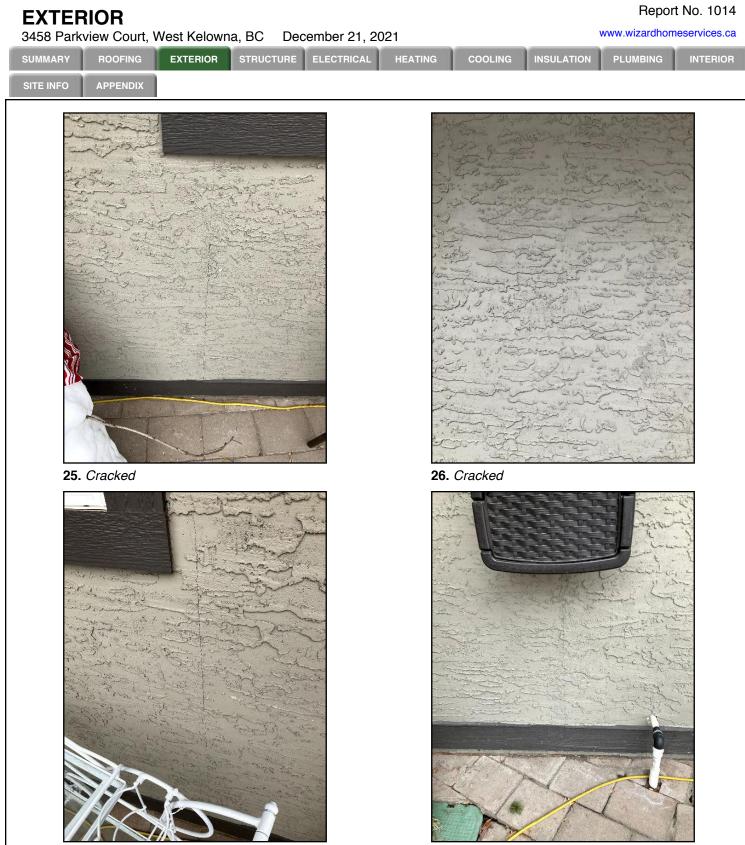
28. Cracked

10. Condition: • Cracks & Damage

Stucco is damaged in various locations and should be repaired to prevent water infiltration.

Task: Repair/Seal all openings and cracks

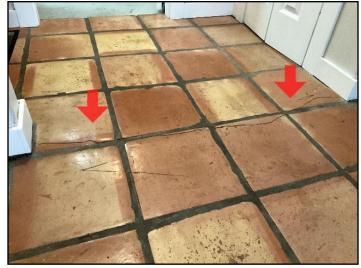
48. Settled

Condition: • Settled

Evidence that the house has settled. Ask seller settlement history and if this is new or old. Ask seller if this issue has been investigated by professional to determine cause and request report. If cracks and settlement are new or no investigation has been conducted, have area further evaluated by engineer to determine cause and provide a recommendation. The slab sounds hollow in areas which indicates possible water undermining.

Task: Further evaluation / Request disclosure

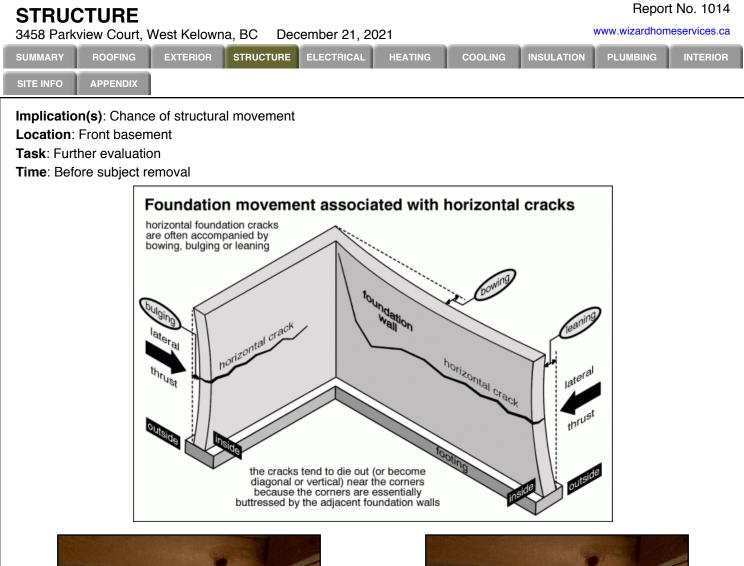
50. Cracked horizontally

23. Condition: • Cracked horizontally

Horizontal cracks larger that 1/8th of an inch found in foundation wall. These cracks should be sealed by processional. Further investigation by foundation specialist is recommended to assure future structural movement is not an issue.

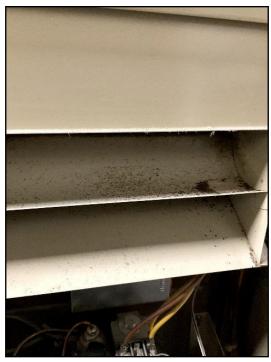
71. Furnace past life expectancy

Condition: • Past life expectancy

Old furnace, have heating specialist estimate remaining life and replacement costs, anticipate replacement. 35 year-old furnace, typically these furnaces last 18 to 25 years. If furnace fails, there will be no heat. Potential health issue if furnace not serviced.

Implication(s): Equipment failure I No heat for building I Possible hazardous combustion products entering home Location: Basement Furnace Room

Task: Further Evaluation

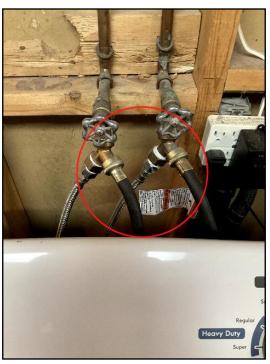
80. Upgrade Washer Hookup

OPTIONAL \ Plumbing 35. Condition: • Upgrade Washer Hookup Rubber supply lines have a history of leaking. Implication(s): Water leaks damage structures and materials Location: Laundry Area Task: Replace with steel braided hoses Time: Discretionary - Monitor www.wizardhomeservices.ca

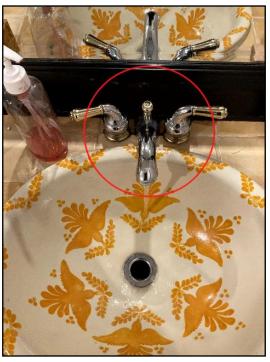
84. Loose taps and faucet

38. Condition: • Loose
Fixtures are loose and can potentially fail and leak if not addressed.
Implication(s): Equipment failure / potential water leak
Location: Basement Bathroom
Task: Improve - Repair
Time: Upon possession

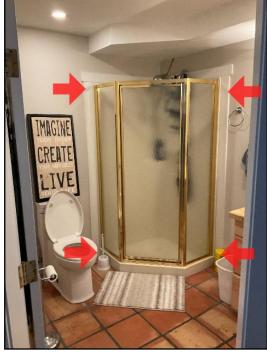
85. Caulking loose, missing or deteriorated

39. Condition: • Caulking loose, missing or deteriorated
Caulking detail required in both upper and basement bathrooms.
Implication(s): Chance of water damage to structure, finishes and contents
Location: Master Bathroom & Basement Bathroom
Task: Reseal all seams and joins exposed to water
Time: Upon possession

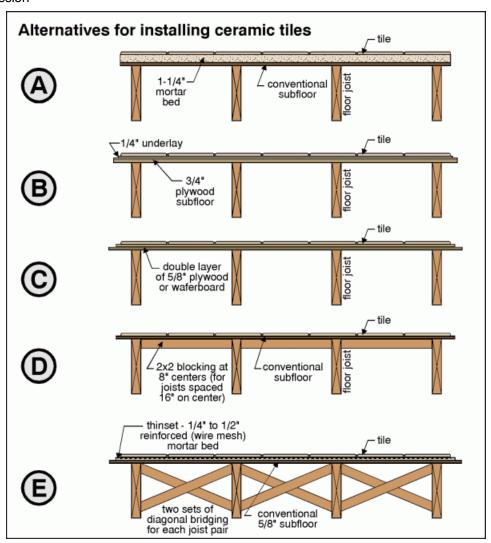
107. Grout loose

FLOORS \ Ceramic tile, stone, marble, etc 43. Condition: • Grout loose

Implication(s): Tiles may become damaged and become a trip or fall hazard

Task: Repair

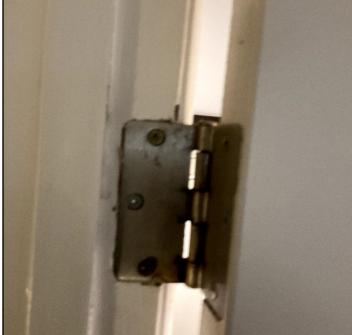
109. Loose or poor fit

44. Condition: • Loose hinges
The door leading to basement has a loose hinge.
Implication(s): Chance of door falling off
Location: Second Floor Basement
Task: Repair
Time: Upon possession

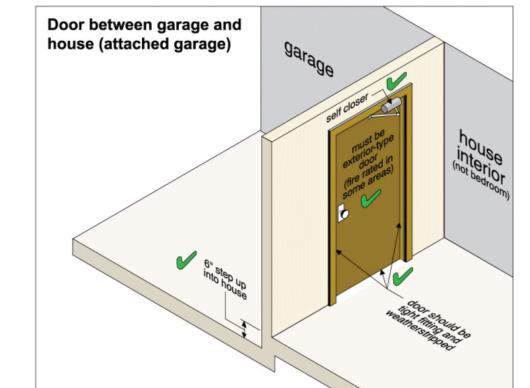
113. No self closer

48. Condition: • <u>No self closer</u>

Implication(s): Hazardous combustion products entering home
